Listed Buildings:

Listed Buildings in Dinton and Westlington outside of Conservation Area Boundaries

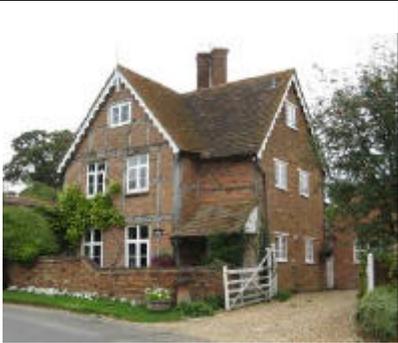
5	Summers Cottage, Ford Road

House	II	<p>House. C16 and C17. Formerly part of one house, but with break in middle. Summers Cottage in north crosswing and Gable Cottage (q.v.) in south crosswing. Timber framed with brick infill on rubblestone plinth. Rubblestone rear wing. Old tile roof. 2 storeys plus attic. Short bay at right remains of centre range. 2 mullioned and transomed casements to gabled front with 2-light casement to attic. Scalloped bargeboards and finial. Right bay set back with 6-panel door under lean-to open porch. 2 diagonal brick flues to centred crosswing with corniced caps. Interior. Ground floor front room has moulded stone arched fireplace with moulded stops and 4-centred arch. Moulded spine and cross beam, the cross beam narrower. Much exposed framing, chamfered and stopped spine beams. Staircase in short right bay which has evidence of jettied and cut brackets to support bressumer.</p>

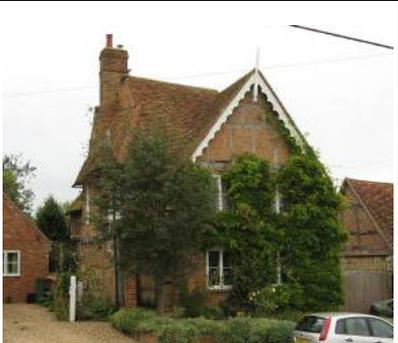
6	Gable Cottage, Ford Road

House	II	<p>House. C16 and C17. Formerly part of one house, but now with break in middle, Gable Cottage is south crosswing and Summers Cottage (q.v.) is north crosswing. Timber-framed with brick infill on rubblestone plinth. Street gable elevation C19 brick. Rear wing timber-framed upper floor, rubblestone ground floor. Upper floor of left bay rubblestone on south side. Old tile roofs. 2 storeys plus attic. 2 two-light leaded casements with segmental arched heads. Herringbone infill to framed gable. Board door in left bay with jettied upper floor, moulded bressumer and cut brackets. 2-light leaded first floor casement. Left or north elevation has 2 blocked fireplaces exposed, both with depressed brick arches formerly heating missing centre range. Tiled hip and C18 flue. Much exposed framing. Summers Cottage and Gable Cottage originally called 'The Dower House'.</p>

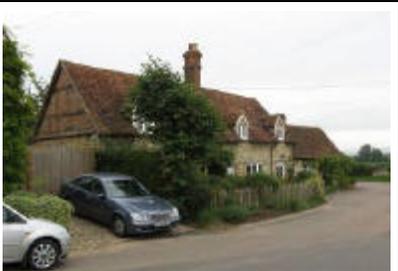
7	Forge Cottage, Ford Road

Cottage	II	<p>Cottage. C17 and C18. Rubblestone with old tile roof some timber framing. Weatherboarded range on rubble plinth at right, formerly the smithy. Old tile roof at lower level than house. One and a half storeys. 3 bays. 4 Panel door between right hand bays in front of stack forming lobby-entry type plan. Board door at far right. Leaded casement windows. 2-light to left bays under timber lintels, 3-light to right bay with cement quoins and arch. 3 two light gabled dormers. Left gable timber framed with brick infill, right gable weatherboarded. Stack between right hand bays. Single-storey range at right has stack.</p>
8	The Bottle and Glass Public House, Gibraltar

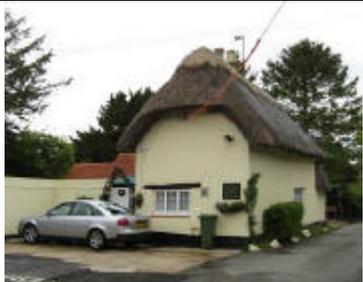
9	The Cottage, Gibraltar

Cottage	II	Cottage. Late C17. Witchert, rendered and colourwashed on a colourwashed rubble plinth. Thatched roof, swept over single storey addition at right. One and a half storeys, 2 bays with single storey further bay at right. 2-light first floor casements. Central stack. Half hipped south gable with 3-light casement.
10	Old Thatch, Gibraltar	No Photo Available	Cottage	II	Cottage. C17, altered. Witchert, colourwashed and rendered on a rubble plinth. Plain tile roof. 2 bays and 1½ storeys. Door in gabled porch at right. 2-light leaded casement windows and eaves dormers. Central stack. Half-hipped roof. Right gable has lean-to witchert outbuilding and the house gable above is tile hung.
11	Gibraltar Cottage, Gibraltar

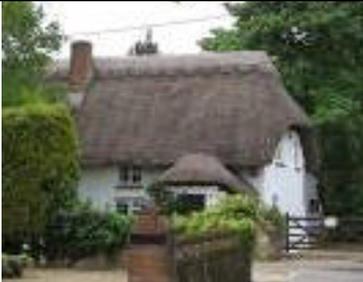
House	II	House, formerly 2 cottages. Early C18. Witchert on a rubble plinth, colourwashed and rendered. Thatched roof, half-hipped gables. 4 bays and 2 storeys. Door in modern thatched porch in right hand bay. 2-light casements to other 3 bays. Eaves dormers to 2 left bays, 2-light casement to third bay under eaves. Flat-roofed single storey rear addition across 2 bays. Stacks to left gable and to centre. Interior. Left hand ground floor fireplace has cambered chamfered and stopped lintel and stone jambs. Chamfered and stopped spine beams.

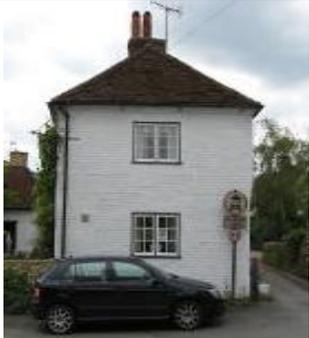
Cottage	II	Cottage. C18. Colourwashed brick. Hipped old tile roof. 2 bays and 2 storeys. Central panelled door in modern gabled porch. Blank window panel above. 2-light casements under flat arches. Centre stack. Rubble plinth and moulded brick eaves. At left 2 bay, 1½ storey wing with modern casements and 2 doors. East gable has 2-light casements.
18	no. 1 (Rose Cottage), no. 2 and no. 3 (Lavendar Cottage), High Street

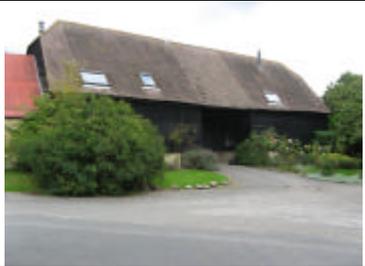
29	Near Barn, Middle Barn and Upton Barn

Barn	II	Barns and cowshed converted into 3 dwellings. C18. L-shaped in plan with barn fronting the road and stretching back from the road a barn and cowshed. Timber-framed and weatherboarded on rubble plinths with some brick dressings. Plain clay tile roofs. Barn fronting road has central cart entry, now utilised as vehicular accessway. Road elevation has slit window at left and 3 roof lights. Half-hipped roof.
30	Lower Farmhouse and Lower Farm Cottage	No Photo Available	Farmhouse	II	Farmhouse. Dated 1678, altered with C19 additions. Rubblestone, upper floor with south range in brick and C19 ranges also brick. Old tile roofs. C17 house with C19 block running north to form open courtyard plan. Single storey north west additions. 2 storeys. Casements to left bay and ground floor centre bay, other 3 windows sashes with glazing bars. Band course. Stack between left bays. West elevation has doorway to left bay. Blocked windows to right bay and large stack between bays. Date plaque in cut bricks on north gable inscribed '1B 1678'. South range roof hipped. North gables of C17 and C19 ranges have stacks.

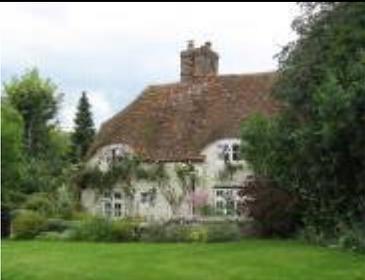
31	Field Cottage

Cottage	II	Cottage. C17, perhaps incorporating earlier fabric. Colourwashed roughcast on witchert. Old tile roof. 3 bays and 1½ storeys. Stack between left hand bays. Doorway at rear. Front has mullioned and transomed casements to ground floor, Eyebrow dormers to left bays with paired casements. Half-hipped gables.
32	Upton Thatch

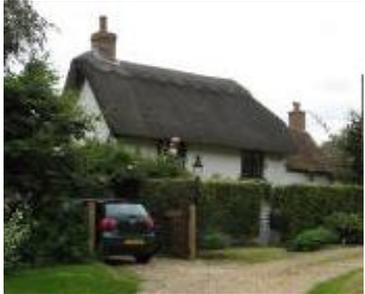
Cottage	II	Cottage. C18. Witchert, rendered and colourwashed. Thatched roof. 2 bays and 2 storeys with 1½ storey tiled roofed right hand addition. Board door in right bay. Leaded casement windows, 2-light except ground floor left bay which is of 3 lights. 2 casements in wing at right. Left hand gable stack and stack to gable of right hand wing.

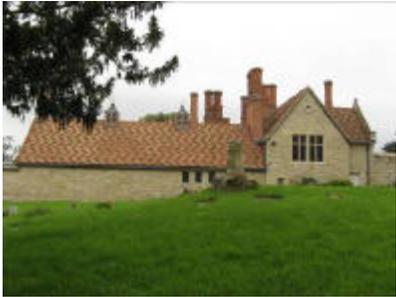
33	Dinton Hall, Upton Road

House	II*	Country house. Circa 1500, enlarged and substantially rebuilt late C16, altered C17 and 1855-1857. West wing and main south front rubblestone, also east elevation of service ranges fronting churchyard. Remainder in brick. Old tile roofs. Two storeys plus attics, service blocks two storey. Half H plan with wings extending to south and service ranges at east. Most brick is late C16. Upper floor windows flanked by broad Doric pilasters. Windows and pilasters cement dressed to simulate stone. Cornice above, then 4 gables with stone coping and finials. Range of eight flues, the outer three each side diagonally set, the inner two square. Main block has 7 bays of stone cross casement windows. Arched entrance at right. Band course and moulded cornice. Hipped dormers to attic. Left wing has ashlar bay window, then 5-light attic stone mullioned window with cornice. Hopper heads dated 1857. Many diagonally set chimneys.

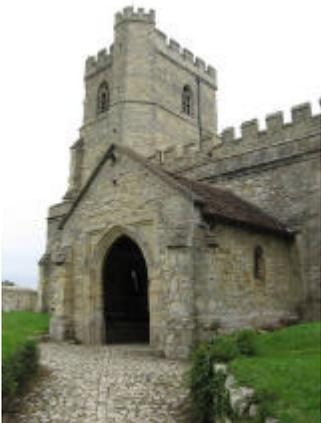
38	Parish Church of Saints Peter and Paul, Upton Road

Parish Church	1	<p>Parish church. C12 (south doorway), c1230 chancel, c1240 south aisle and south arcade, nave north wall c1400, south aisle widened and west tower added C15. South porch c1500. Chancel lengthened by 3m. 1868. 3 bay chancel, 5 bay nave with south aisle, south porch and west Tower. Coursed rubblestone with stone dressings. Chancel roof has old tiles, nave, aisle and tower have lead roofs. Chancel has lancet windows. Moulded abacus string continues as hood over windows. Nave has crenellated parapet. South clerestory has quatrefoil windows. South aisle has coped parapet. Examples of trefoil, quatrefoil and cinquefoil windows. Weathered buttresses between and to south aisle. West tower has 2 stages, the lower with weathered angle buttresses. Crenellated parapets and octagonal south east stair turret. South porch has angle buttresses and pointed arch of 2 chamfered orders in square head. . South doorway into church c1140 with splendid Romanesque ornament. Porch roof c1500 queen struts to collar cambered tie beams and chamfered purlin braces. Moulded purlins, trusses and wall plates.</p>

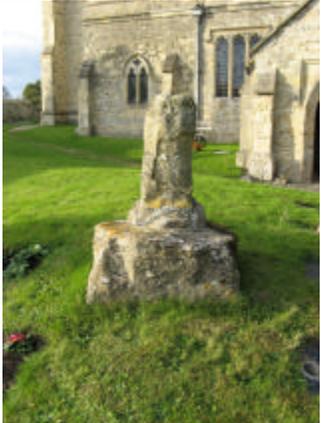
39	Base of Churchyard Cross 7m south of porch of Parish Church of Saints Peter and Paul, Upton Road

Monument	II	<p>Base of churchyard cross. C15. Stone. Octagonal plinth with spurs. Remains of moulded base. Octagonal shaft.</p>
40	The Glebe House, Upton Road

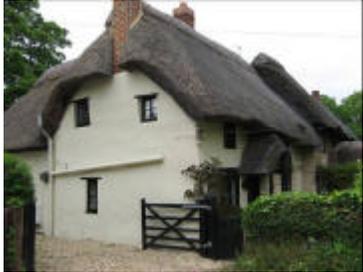
47	Meadows Edge and Morland Cottage

Cottage	II	<p>Pair of cottages. C18. Rubblestone with brick dressings. Thatched roof. 2 storeys and 4 bays. Left bay Meadows Edge, other 3 bays Morland Cottage. Entrances in modern rubblestone thatched porches, to Meadows Edge off centre with 3-light leded front window; between left bays of Morland Cottage with 2-light front window. Meadows Edge has 4-light leded ground floor casement under oak lintel. Morland Cottage has 3-light ground floor casements, outer ones with segmental brick arches, centre one with oak lintel. 3-light first floor casements to both cottages. Stacks between bays one and 2, and bays 3 and 4.</p>
48	no. 1 Jasmine Cottages, Wootton Lane

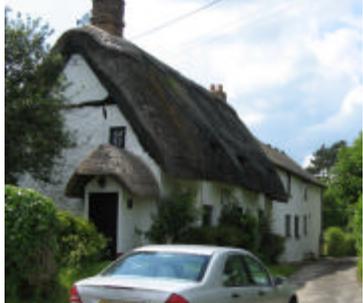
Cottage	II	<p>Cottage. Dated 1762. Witchert, colourwashed and roughcast on a painted rubblestone plinth. Thatch roof 1½ storeys and 3 bays. Central door. 2-light casements, the right hand pair with segmental headed lights. 3 two-light dormers. Left hand stack. Thatched board porch to left gable with board door. Rubblestone stack, painted, timber tie and collar exposed with painted brick infill. Date plaque to left of door on main front inscribed 'IPR 1762' in frame with love knot motif above. This may refer to a marriage rather than the date of construction which appears earlier than 1762.</p>

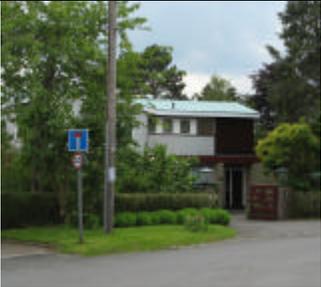
5	Pinehill, High Street

House	<p>House. C20. An interesting example of unusual modern design in the historic environment. The use of unusual materials such as copper sheeting and timber boarding gives the building a distinctive appearance. The building is easily visible in views along New Road and High Street, occupying a prominent position on the junction between the two streets.</p>
6	Saddlestones, High Street

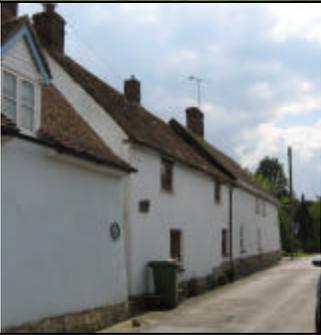
7	Witchert Cottage and Valentine's Cottage, High Street

Cottage	<p>Cottage. Possibly C17 and C18 with later additions. Witchert on a rubblestone plinth, colourwashed and rendered with old tile roof. Small casement windows and short chimney stacks. The building abuts the street edge creating a strong sense of enclosure on the High Street.</p>
8	Chestnut Cottage

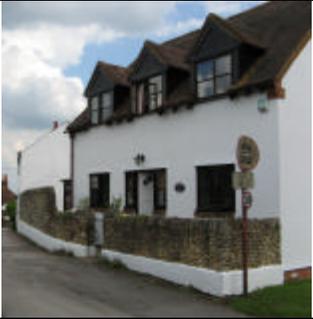
12	Starbank House, Stars Lane

Barn	House. C19, possibly with older material within. Rendered and whitewashed with tiled roof and gables dormers at eaves level. Symmetrical frontage with small casement windows and central recessed door. Small front yard bounded by short rubblestone wall.
13	Westlington Barn, Stars Lane
